Manhole Inspection Summary

Manhole # S31I__027MH

Location Address: **101 w lombard st**

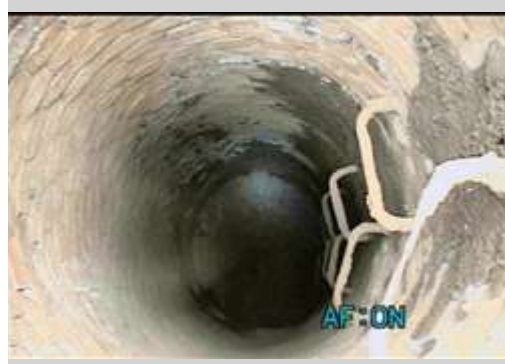
Top View

top view & steps

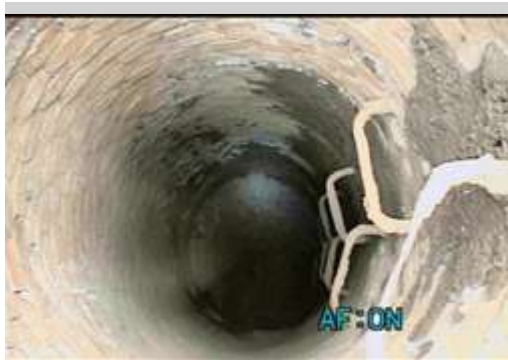
Defect 3

Infiltration: ☐ None ☐ Joint ☐ Cracks ☐ Mortar ☐ Roots ☒ **Wall**

Count: **9** Missing: **0** ☒ **Corroded**

chimney infiltration, corroded steps

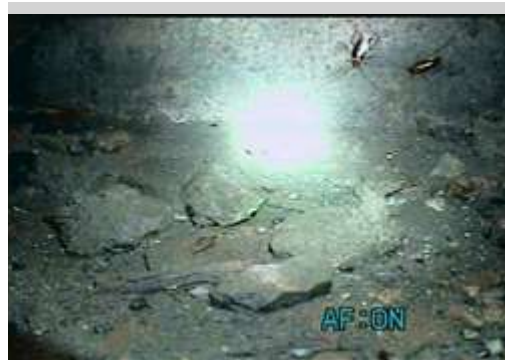
Defect 2

Condition: ☐ Sound ☐ Cracked ☐ Root Intrusion ☐ Deteriorated ☐ Leaks ☒ **Debris**

channel debris

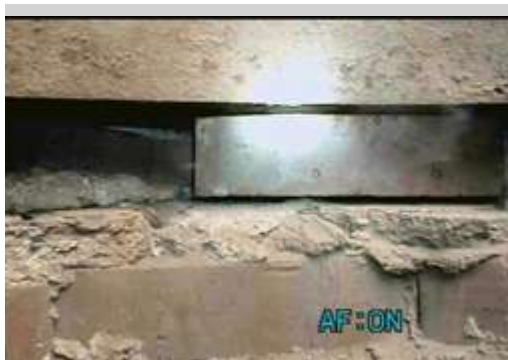
Defect 1

Condition: ☐ Sound ☒ **Cracked** ☐ Root Intrusion ☒ **Loose Brick** ☐ Deteriorated

chimney cond cracked, loose bricks

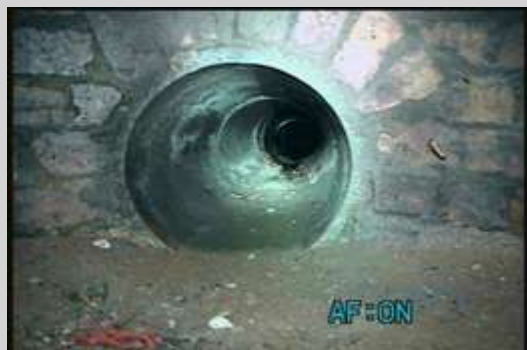
12 O'Clock Outflow

8 in. Circular Gravity Sewer
Pipe Out @ 12 O'Clock
